# Charcoal in sediment layers: A way to estimate impact of land use intensification on reservoirs siltation?

Anne Weiss<sup>a</sup>, P. Schmitter<sup>a</sup>, T. Hilger<sup>a</sup>, Sabine Fiedler<sup>b</sup>, N. Thanh Lam<sup>c</sup>, Georg Cadisch<sup>a</sup>

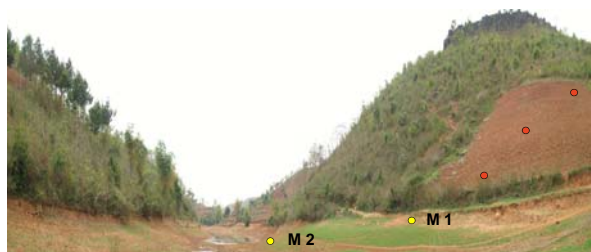
Fig. 1. Soil auger points (●) and profile pits (○) under land use maize

- Main land use systems around the lake are sole or intercropped maize and cassava, agroforestry and secondary forest (bamboo). Below each land use, two profiles 10 m apart were excavated to 2m in the lake bed (Fig. 1). Visible distinguishable sediment layers were investigated regarding thickness, colour, texture, particle size distribution and total organic carbon (TOC).

- Land use change started with planting of teak in 1995. Since 1999 there is maize cultivation on M2 adjacent upland plot (Fig. 1) suggesting that erosion from these plots led to min. 30 cm sedimentation yield.

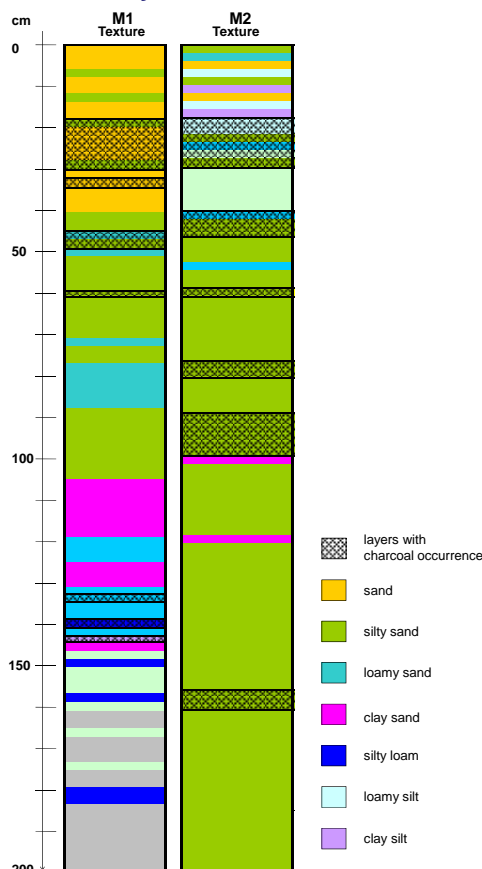
Fig. 3. Charcoal findings in soil profiles M1 and M2

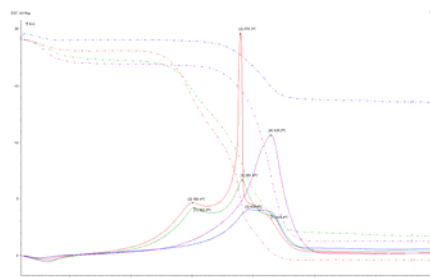
Fig. 4. Differential Scanning Calorimetry curves of different plant materials:  
— Bamboo — Teak — Maize — Cassava  
Pointed lines: mass loss

- Distinctive DSC peaks for charcoal from bamboo, cassava and forest occurred with calibration plant materials (Fig.4).
- DSC analysis of M2, cm 25-29, revealed 3 peaks (Fig. 5) of which second and third were at similar temperatures as bamboo and maize/teak respectively (Fig.4).

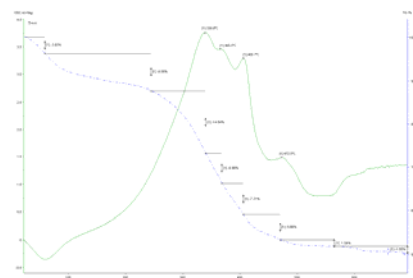
Fig. 5. DSC of charcoal found in 25-29 cm depth in the lower maize profile (M2)

- As the distinctive forest charcoal peak (428°C) was not present in sediment sample (Fig 5) the isolated sediment charcoal was probably derived from disturbed (bamboo) natural or planted teak/maize systems.
